# **Environmental Exposure Effects on DOT-CFFC Cylinders with Modal Acoustic Emission Examination**

**JUNE 2015**

US DOT/PHMSA  
Mark Toughiry, PE  
1200 New Jersey Ave, SE  
Washington, DC 20590  
+1 (202) 366 – 4545

Digital Wave Corporation  
Dr. Brian Burks, Dr. Steven Ziola, Dr. Michael Gorman  
13760 E Arapahoe Road  
Centennial, CO 80112  
+1 (303) 790-7559 x13

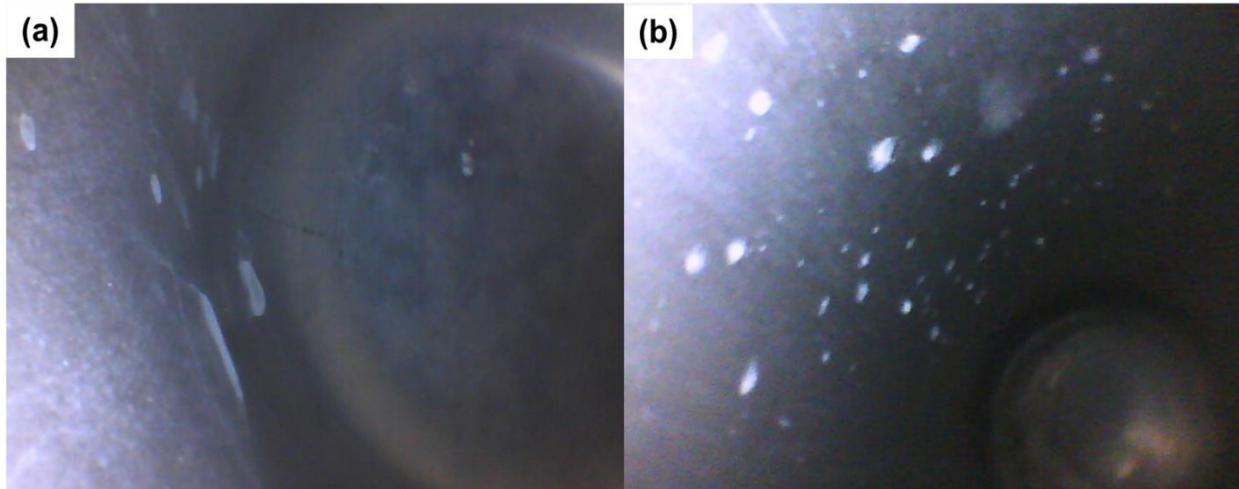
**Figure 5.1 – Internal visual inspection image from borescope imaging (a) prior to, and (b) post hard water exposure.**

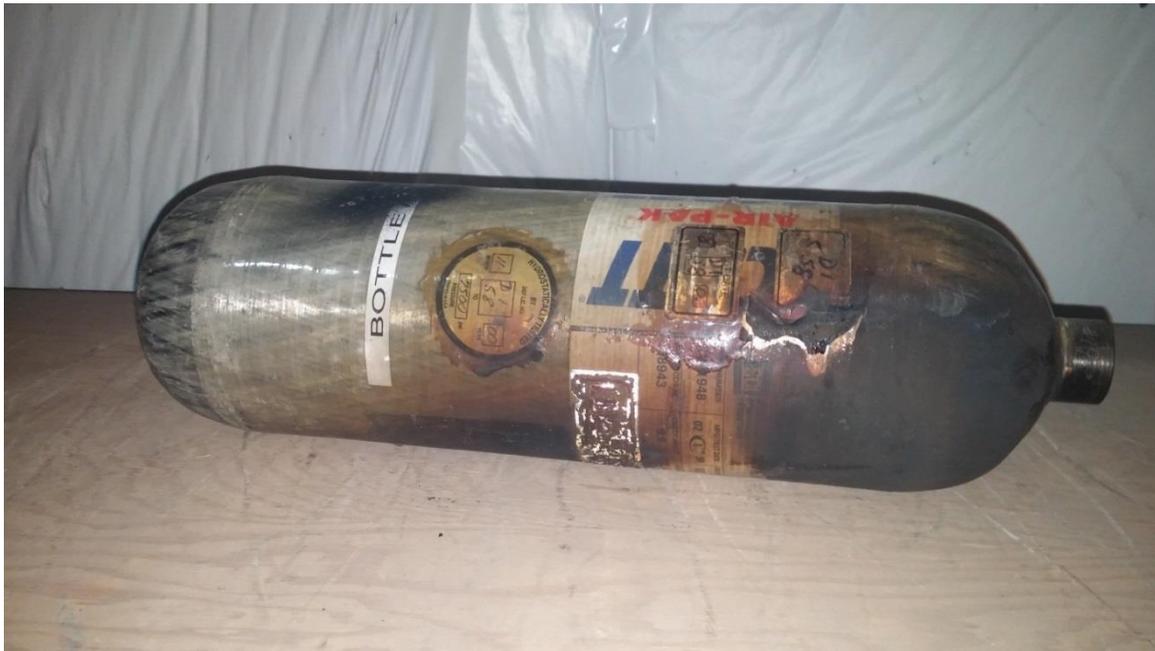
**Figure 5.2 – Cylinder exhibiting minor fire exposure damage.**

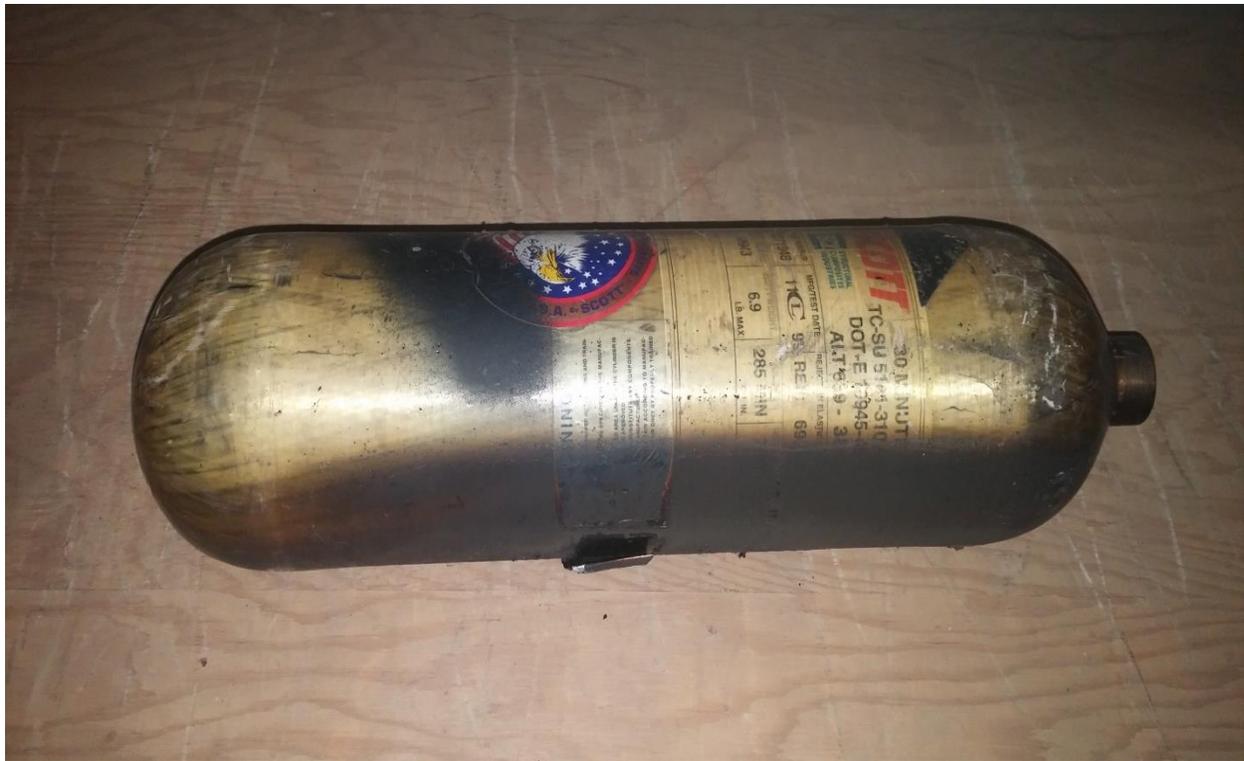
Figure 5.3 – Cylinder exhibiting moderate fire exposure damage.

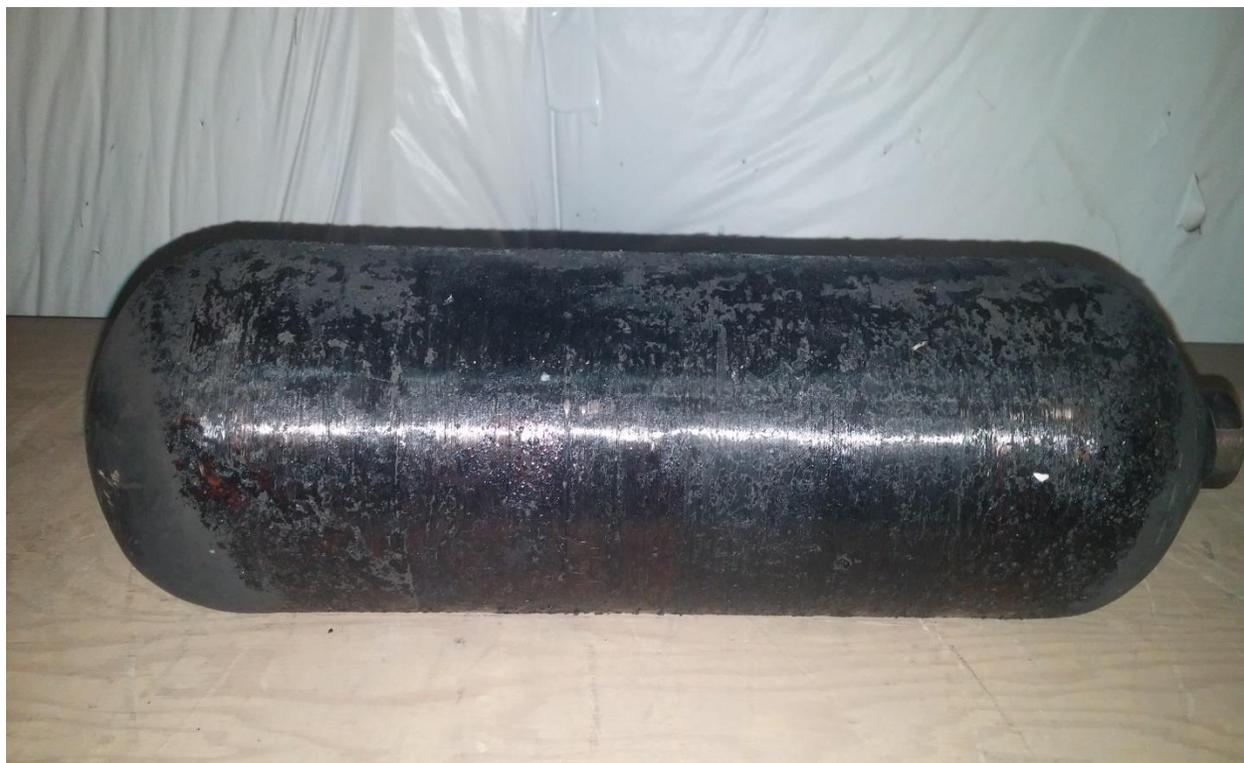
Figure 5.4 – Cylinder exhibiting severe fire damage.

Fire exposure of DOT-CFFC pressure cylinders was found to be potentially damaging to the composite cylinder's strength and fatigue performance. Any cylinder which exhibits Level 3 fire damage should not be put back in to service. It is pointed out that all fire exposed cylinders would have been visually rejected, as all cylinders exhibited Level 3 fire exposure damage as defined by CGA C6.2. While this report focused on expired service life cylinders, the potential for material property degradation had nothing to do with the cylinder's age, but rather the extremely damaging nature of fire exposure on carbon fiber reinforced epoxy composite pressure cylinders.

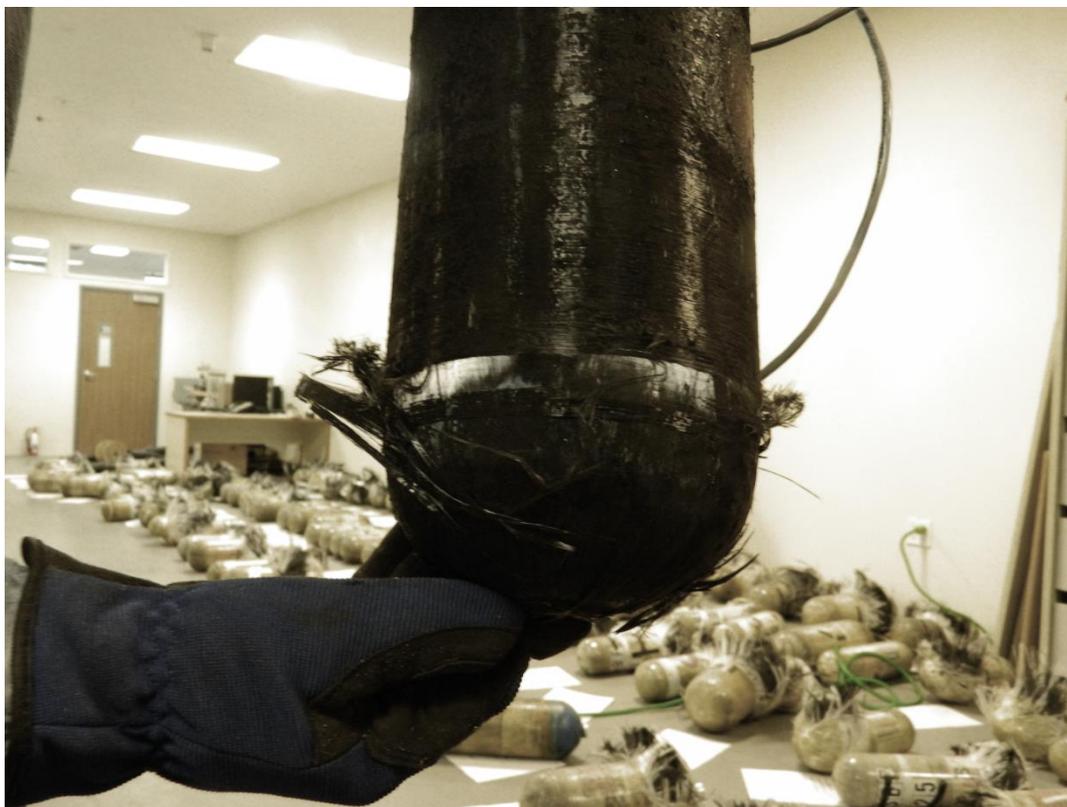
Figure 7.10 – Severe fire exposure damage showing fiber tow unraveling, and epoxy resin loss (ALT 639-9769).

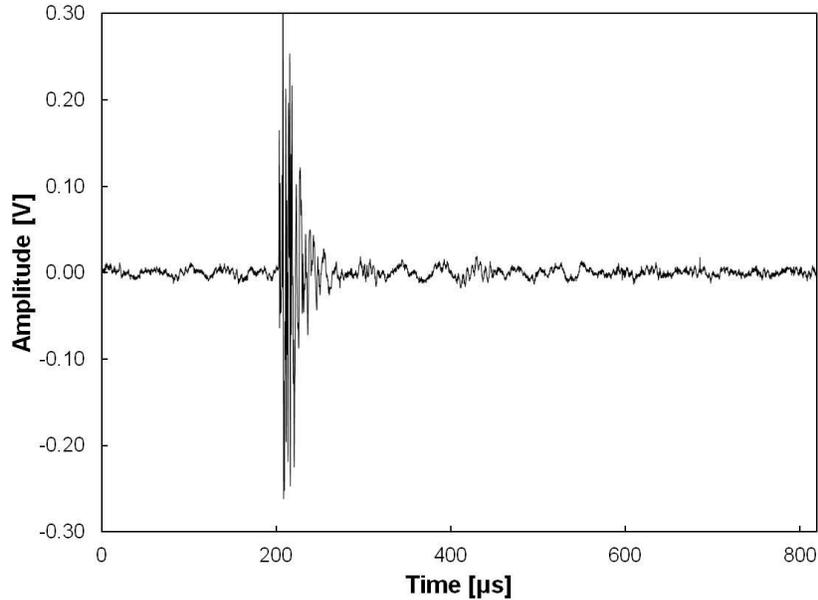
**Figure 7.11 – Multiple fiber tow fracture event recorded during the first test pressure cycle of ALT639-17831 at a pressure of 1,700 psig.**

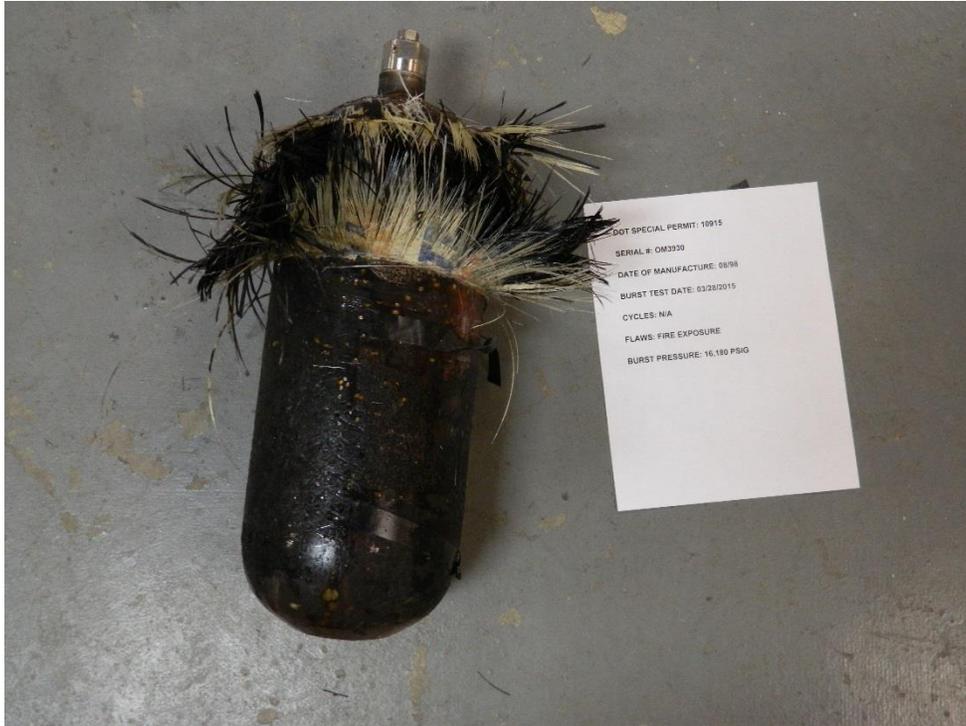
DOT SPECIAL PERMIT: 10015  
SERIAL #: OM3920  
DATE OF MANUFACTURE: 08/98  
BURST TEST DATE: 03/28/2015  
CYCLES: N/A  
FLAWS: FIRE EXPOSURE  
BURST PRESSURE: 16,180 PSIG

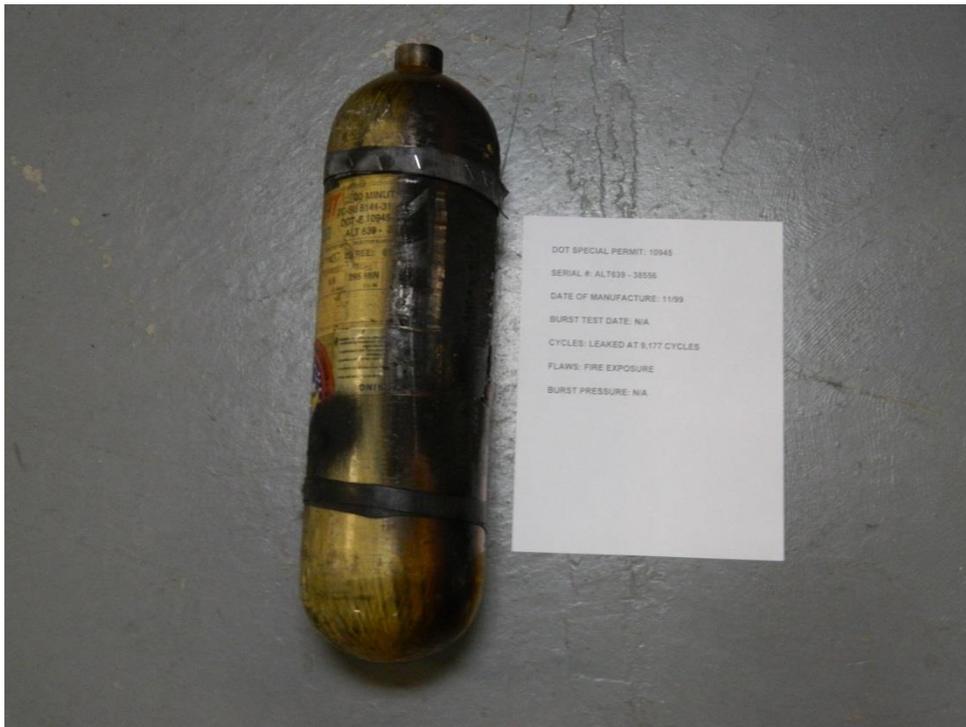
DOT SPECIAL PERMIT: 10045  
SERIAL #: ALT639 - 38556  
DATE OF MANUFACTURE: 11/99  
BURST TEST DATE: N/A  
CYCLES: LEAKED AT 9,177 CYCLES  
FLAWS: FIRE EXPOSURE  
BURST PRESSURE: N/A

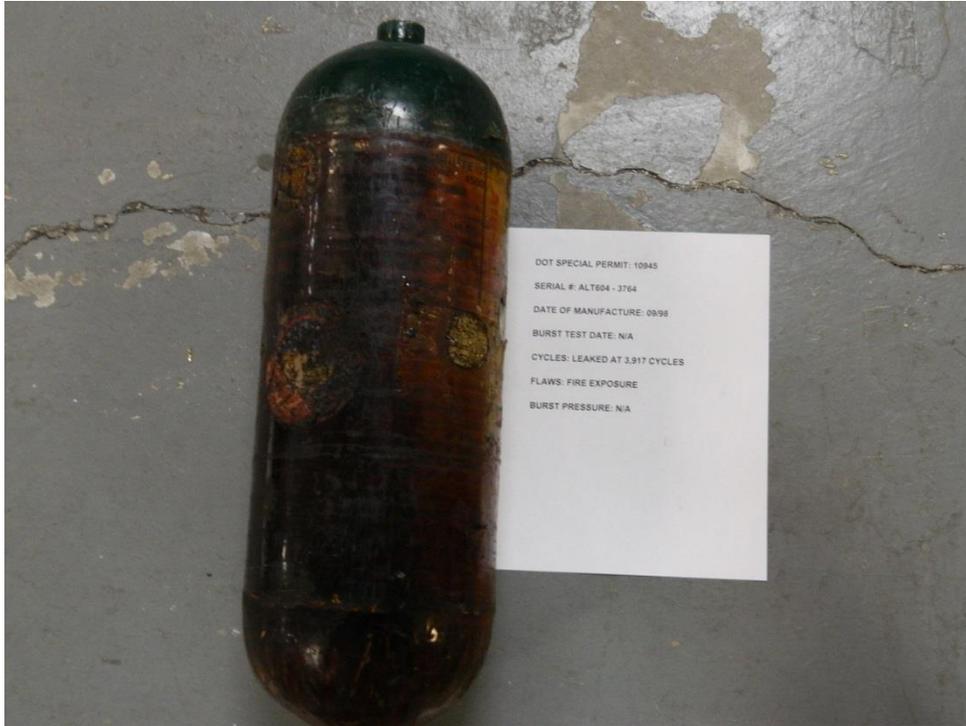
DOT SPECIAL PERMIT: 10945  
SERIAL #: ALT604-3764  
DATE OF MANUFACTURE: 09/98  
BURST TEST DATE: N/A  
CYCLES: LEAKED AT 3,917 CYCLES  
FLAWS: FIRE EXPOSURE  
BURST PRESSURE: N/A

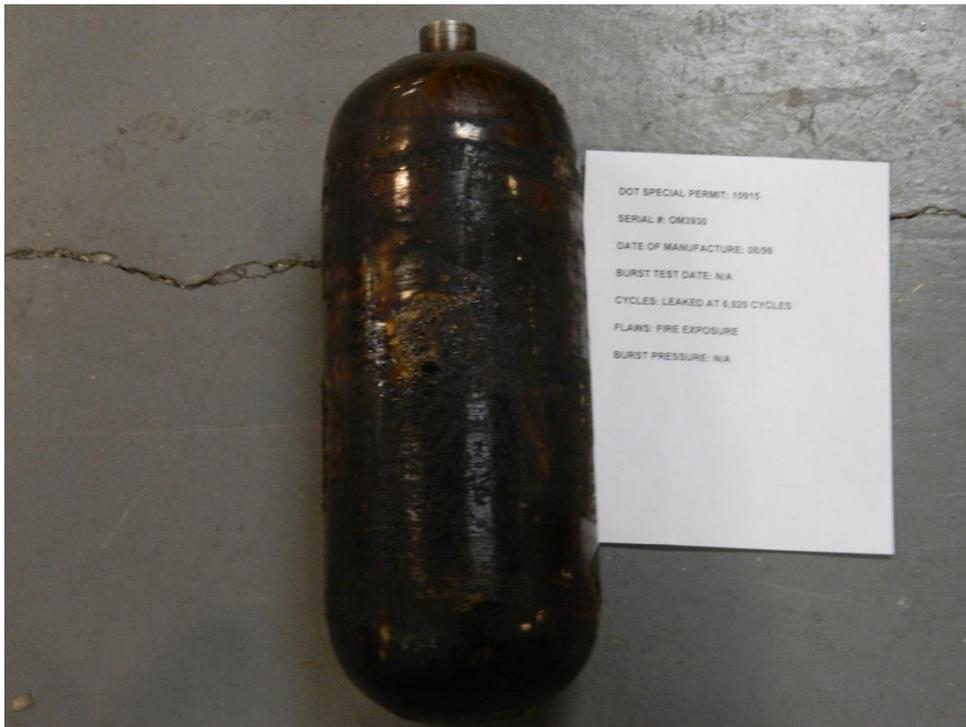
DOT SPECIAL PERMIT: 10915  
SERIAL #: OM3930  
DATE OF MANUFACTURE: 05/98  
BURST TEST DATE: N/A  
CYCLES: LEAKED AT 6,926 CYCLES  
FLAWS: FIRE EXPOSURE  
BURST PRESSURE: N/A
